## BROOKS RECREATION COMPLEX HARD SURFACE RESTORATION PROJECT FINALLY – A LONG-TERM SOLUTION

After seven years of discussions, review, research, and planning, the Brooks Field Hard Surface Restoration Project is approaching reality. This document explains serious ongoing problems with the complex and the Colony Board's plan to resolve them. The approved solution follows recommendations from an appointed study committee, which consisted of dedicated Colony volunteers. Their recent work was a continuation of efforts that began in 2020.

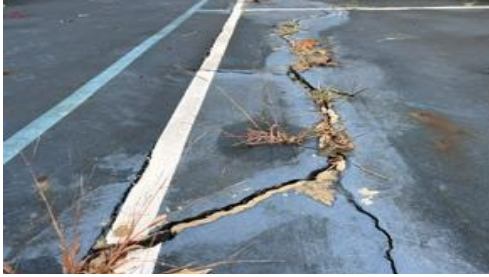
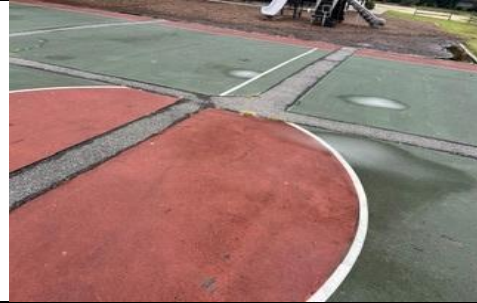
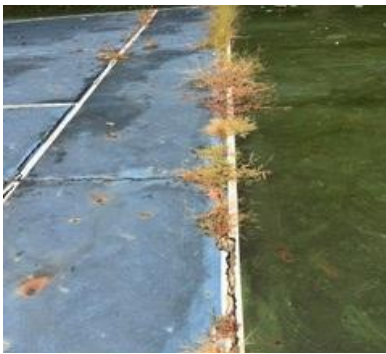
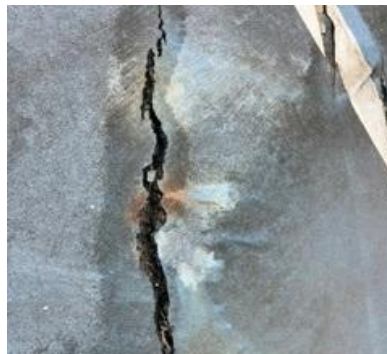
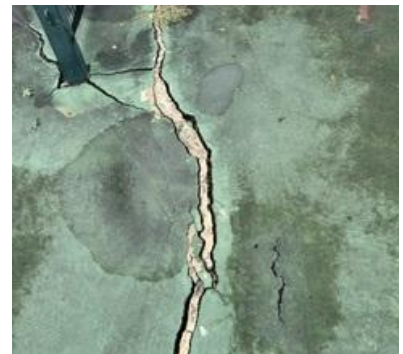
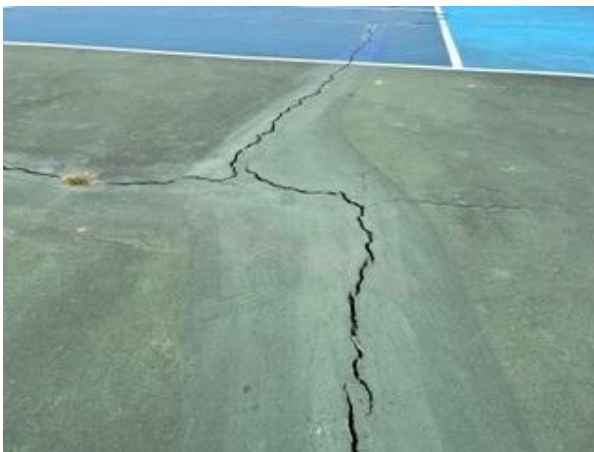
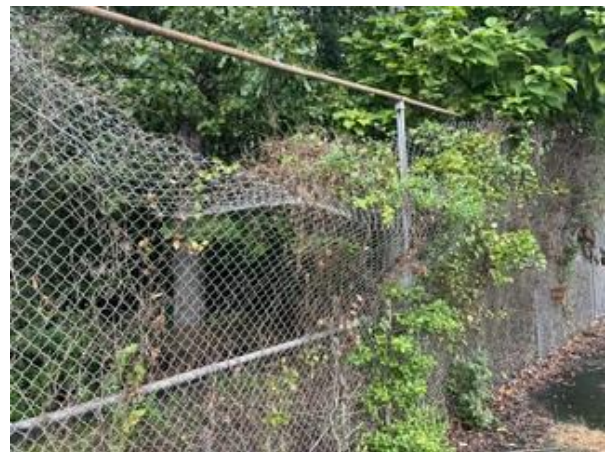
## Understanding the Project In Photos

These recent photographs show conditions that exist throughout the Brooks complex. They are representative of conditions on the current tennis, pickleball, and basketball courts. They are the direct result of base-construction that does not work in Pinelands soil. These conditions have existed since the beginning of hard-court play, but not addressed. The recommended solution involves applying a post-tension slab foundation with a 50-year useful life.

- Uneven playing surfaces, deteriorated to the point that they are beyond a reasonable standard of use
- A crumbling base and disintegrating asphalt that is more like gravel in some areas
- Thick cracks – some as wide as an inch – that are approaching the level of being a safety concern, which could prompt closure
- Sink holes, which could become a tripping hazard
- Peeling court surfaces and broken lines
- Rusted, damaged, and detached fencing

Failing hard surfaces have plagued this facility since its first paving in 1957. The root cause is its location on the Pinelands' high water-table and inadequate base construction. The underlying base is fine sand, which was once the Atlantic Ocean floor. This base leads to constant soil shifting and heaving. Asphalt does not have the tensile strength to overcome this movement. Throughout its history, Brooks paved court surfaces have suffered from the severe cracking that comes from underground hydro-static pressure.
